# First-class upgrade

Series of bridges in Phoenix strengthened successfully

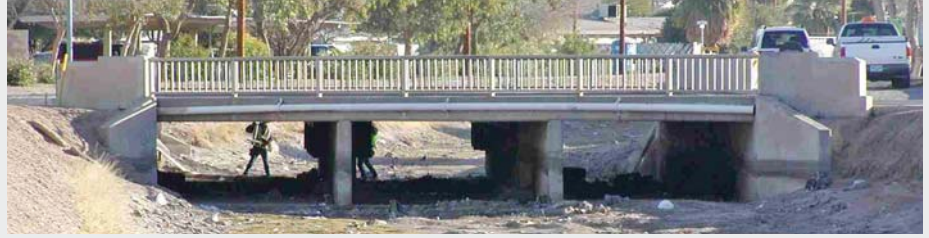
### The 19th Avenue Bridge

- Commercially available high-strength, unidirectional carbon fiber wrap (SiKaWrap Hex 103C) was used for the rehabilitation of the slab soffit;
- Carbon fiber rebar (Aslan 200 Bar by Hughes Brothers) embedded in the concrete was used over the pier locations;
- For the positive-moment regions, two layers of SiKaWrap Hex 103C 12 in. wide by 15 ft long spaced at 36 in. on center were bonded to the soffit using a high-strength adhesive (Sikadur Hex 300) as recommended by the manufacturer; and
- For negative-moment regions over the piers, 63½-in.-diam. Aslan 200 CFRP bars were near surface mounted in grooves using high-strength adhesive (Sikadur 32) as recommended by the manufacturer.

the design of the externally bonded CFRP fabrics called for 12-in.-wide strips spaced at either 36 in. or 20 in. on center for the positive-moment regions. The concrete surface that contained irregularities and cracks was restored with nonshrink mortar (Sikadur 30 or Sikatop 123). After surface

The required number of near-surface-mounted CFRP bars was determined to be 63 for the 19th Avenue Bridge and 43 for the 16th Street Bridge. Also, 1/2-in.-diam. Aslan 200 CFRP bars were near surface mounted in grooves using high-strength adhesive (Sikadur 32) as recommended by the manufacturer. The CFRP bars were embedded in 1-in.-deep by 3/4-in.-wide grooves cut into the bridge deck over the piers.

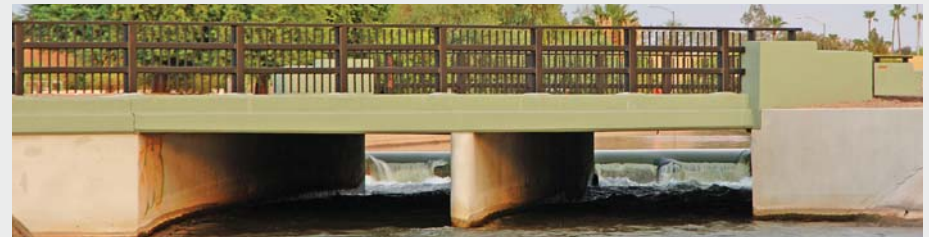
### The 16th Street Bridge

- Similarly commercially available SiKaWrap Hex 103C was used for the soffit;
- Aslan 200 CFRP bars were embedded in the concrete over the pier location;
- For the positive-moment regions, two layers of SiKaWrap Hex 103C 12 in. wide spaced at 20 in. on center were bonded to the soffit using a high-strength adhesive (Sikadur Hex 300) as recommended by the manufacturer; and
- For negative-moment regions over the pier, 43½-in.-diam. Aslan 200 CFRP bars were near surface mounted in grooves using high-strength adhesive (Sikadur 32) as recommended by the manufacturer.

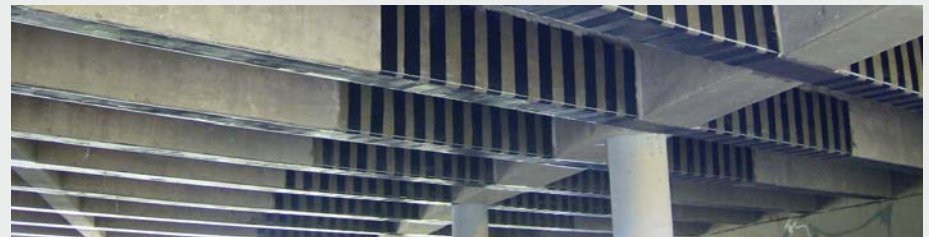
### The Thunderbird Road Bridge

- Required shear and flexure strengthening of the concrete T-beams;
- Strengthening this bridge for shear loads at the supports was achieved by applying a single layer of 6-in.-wide U-wrap SiKaWrap Hex 103C spaced at 12 in. with main fibers oriented in the vertical direction; and
- A single layer of continuous SiKaWrap Hex 103C wrap also was installed with main fibers oriented along the longitudinal beam axis on all beams.

The T-beams of the Thunderbird Road Bridge required shear strengthening. To increase the shear strength of the existing concrete T-beams, a single layer of 6-in.-wide U-wrap SiKaWrap Hex 103C spaced at 12 in. with main fibers oriented in the vertical direction was installed to achieve full bond with concrete surfaces on the sides of the beam. The U-wraps were installed at locations of maximum shear over the supports.

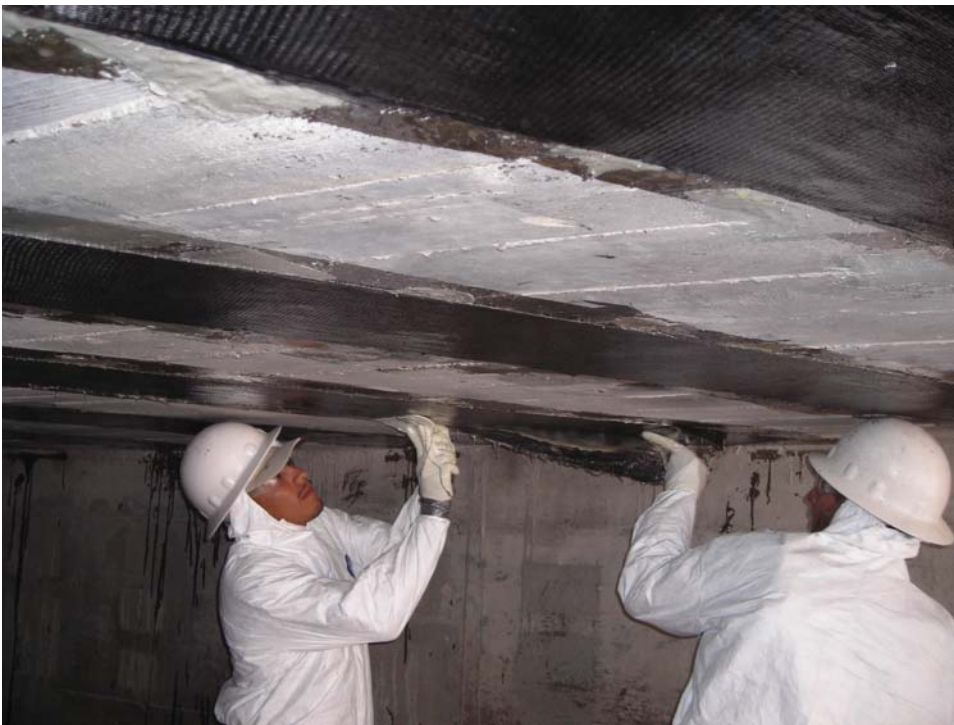
Application of CFRP fabric strips at the soffit on the 19th Avenue Bridge.

preparation that included air blasting, CFRP strips were bonded to the concrete soffit.

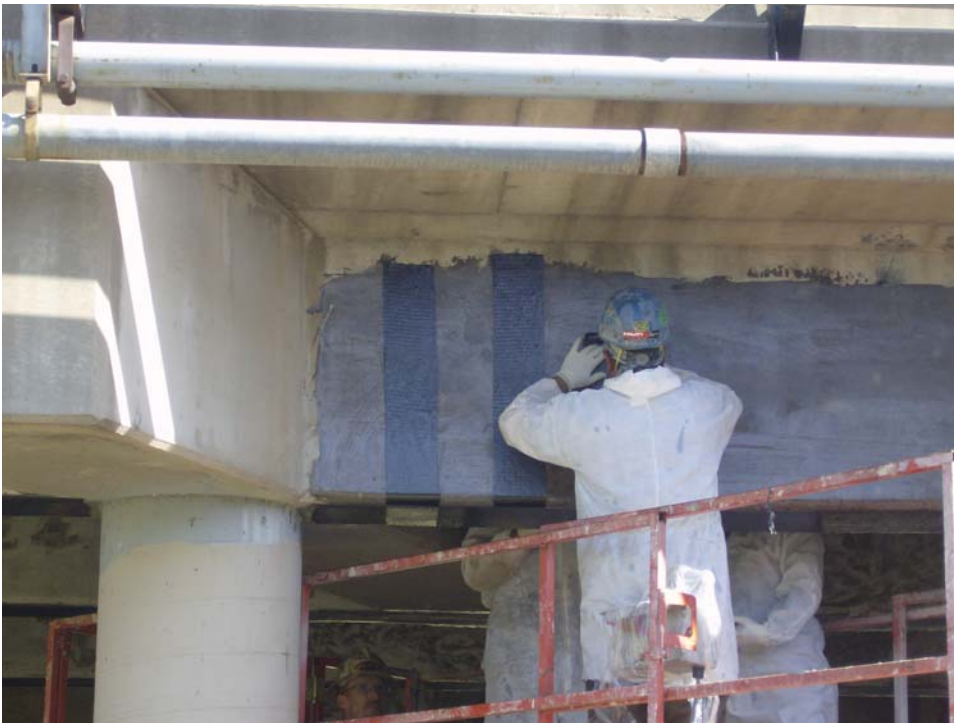
CFRP U-wraps installed on T-beams of the Thunderbird Road Bridge.

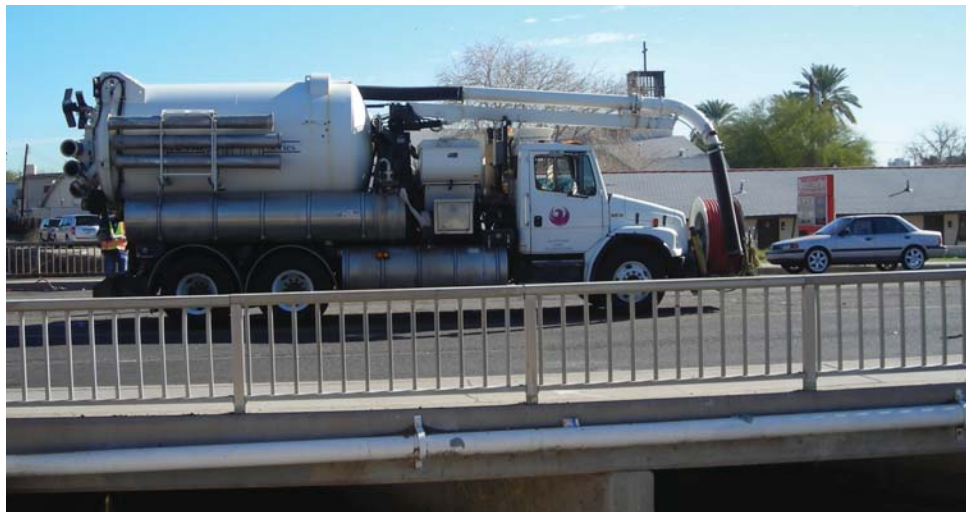
Two city of Phoenix loaded water trucks were used for the static load testing. These trucks had a three-axle configuration with a gross vehicle weight of 60 kips.

Two city of Phoenix loaded water trucks were used for the static load testing. These trucks had a three-axle configuration with a gross vehicle weight of 60 kips. A single truck was positioned with the center of the rear axles at midspan of each of the three spans of the bridge to produce the maximum positive moment in each of the three spans, while two rear axles from both trucks were placed on either side of the piers to produce the maximum negative moment.
